Operation UPSHOT-KNOTHOLE

Project 5.1

ATOMIC WEAPON EFFECTS ON
AD TYPE AIRCRAFT IN FLIGHT (U)

HEADQUARTERS FIELD COMMAND, ARMED FORCES SPECIAL WEAPONS PROJECT
SANDIA BASE, ALBUQUERQUE, NEW MEXICO

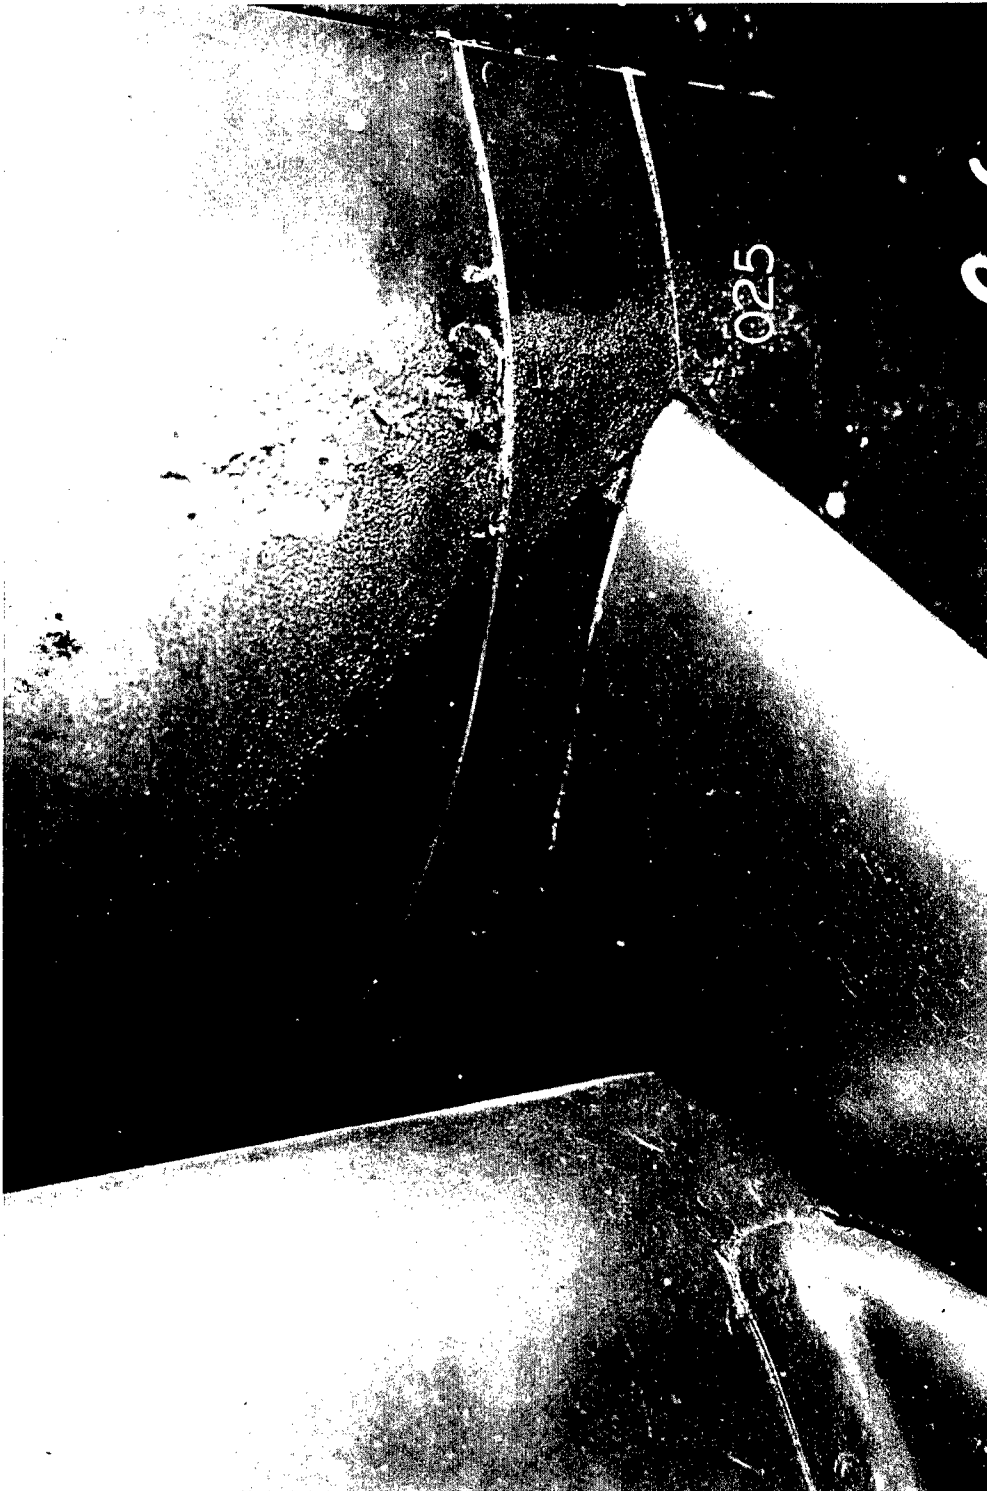
Fig. 2.4 AD-2, Port Wing Flap Showing Scorched Blue Paint on 0.020 Skin, and on 0.025 Skin Forming Curved Portion Aft of Rear Shear Web Facing the Burst - Shot 2

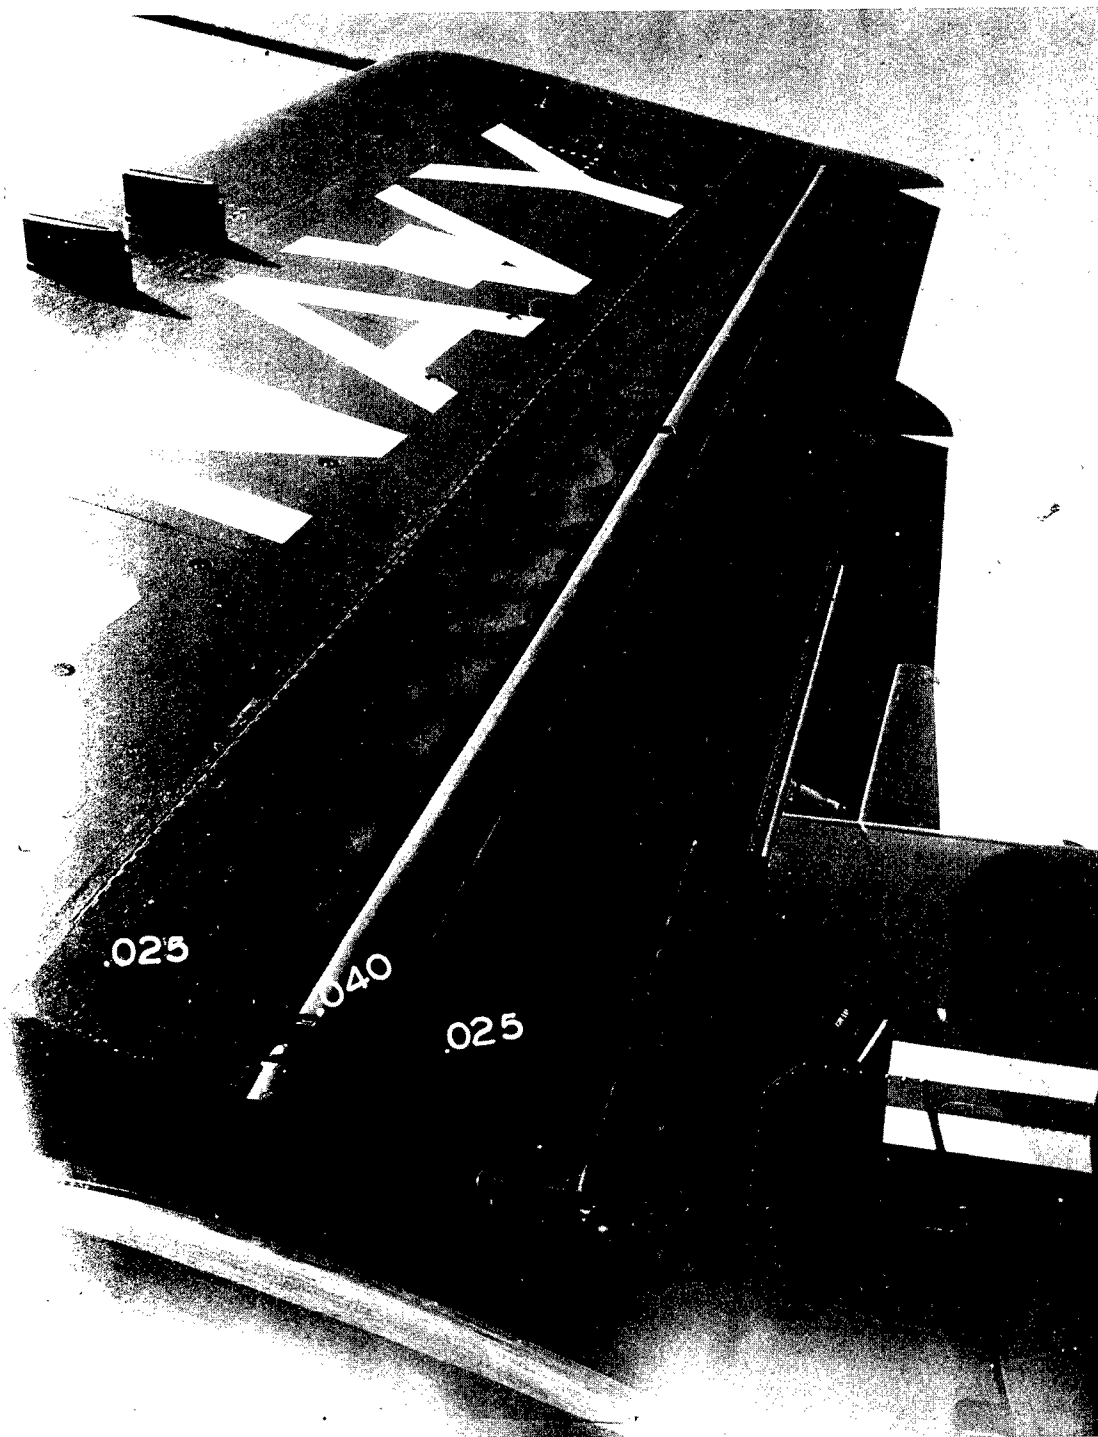
Fig. 2.5 AD-2, Port Wing Flap Showing Scorched Blue Paint on 0.025 Skin Forming Curved Portion Aft of Rear Shear Web Facing the Burst - Shot 2

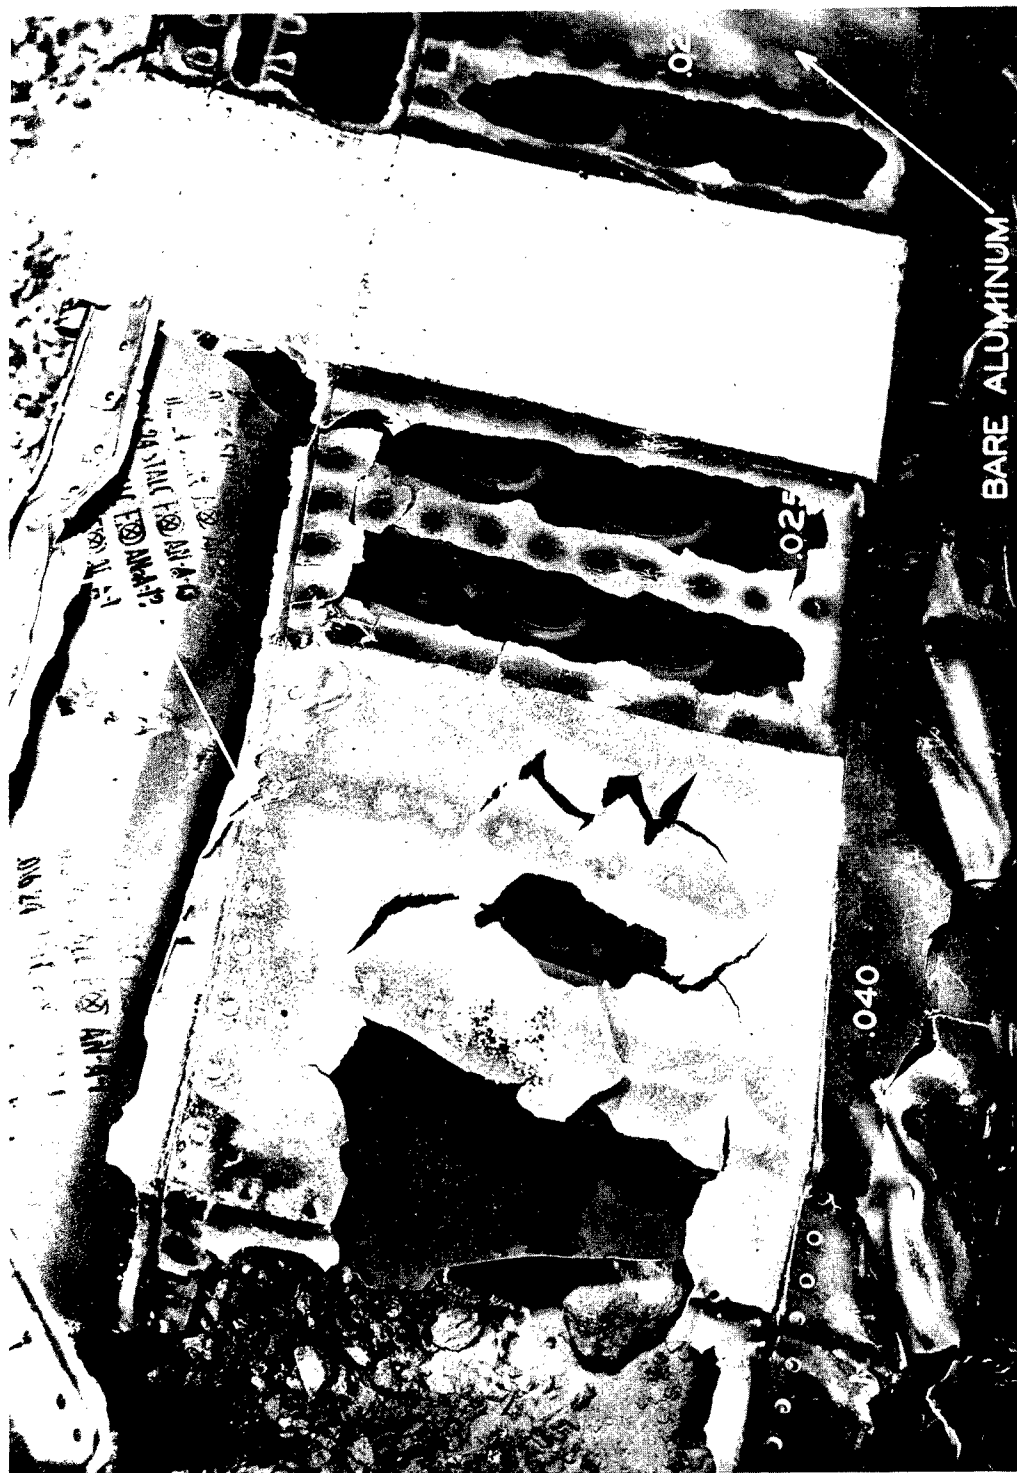
Fig. 2.11 AD-2. Port Aileron Showing Aileron Seal Intact - Shot 7

The fabric lightening hole covers destroyed in Shot 2 were replaced with fabric covers coated with aluminized lacquer. These covers were slightly scorched but not burned through (see Fig. 2.19). Aileron seals remained intact (see Fig. 2.11). The top side of the wing gave no indication of thermal damage other than softening of standard blue paint on 0.016 skin on the aileron (see Fig. 2.20) where the under side skin was completely destroyed.

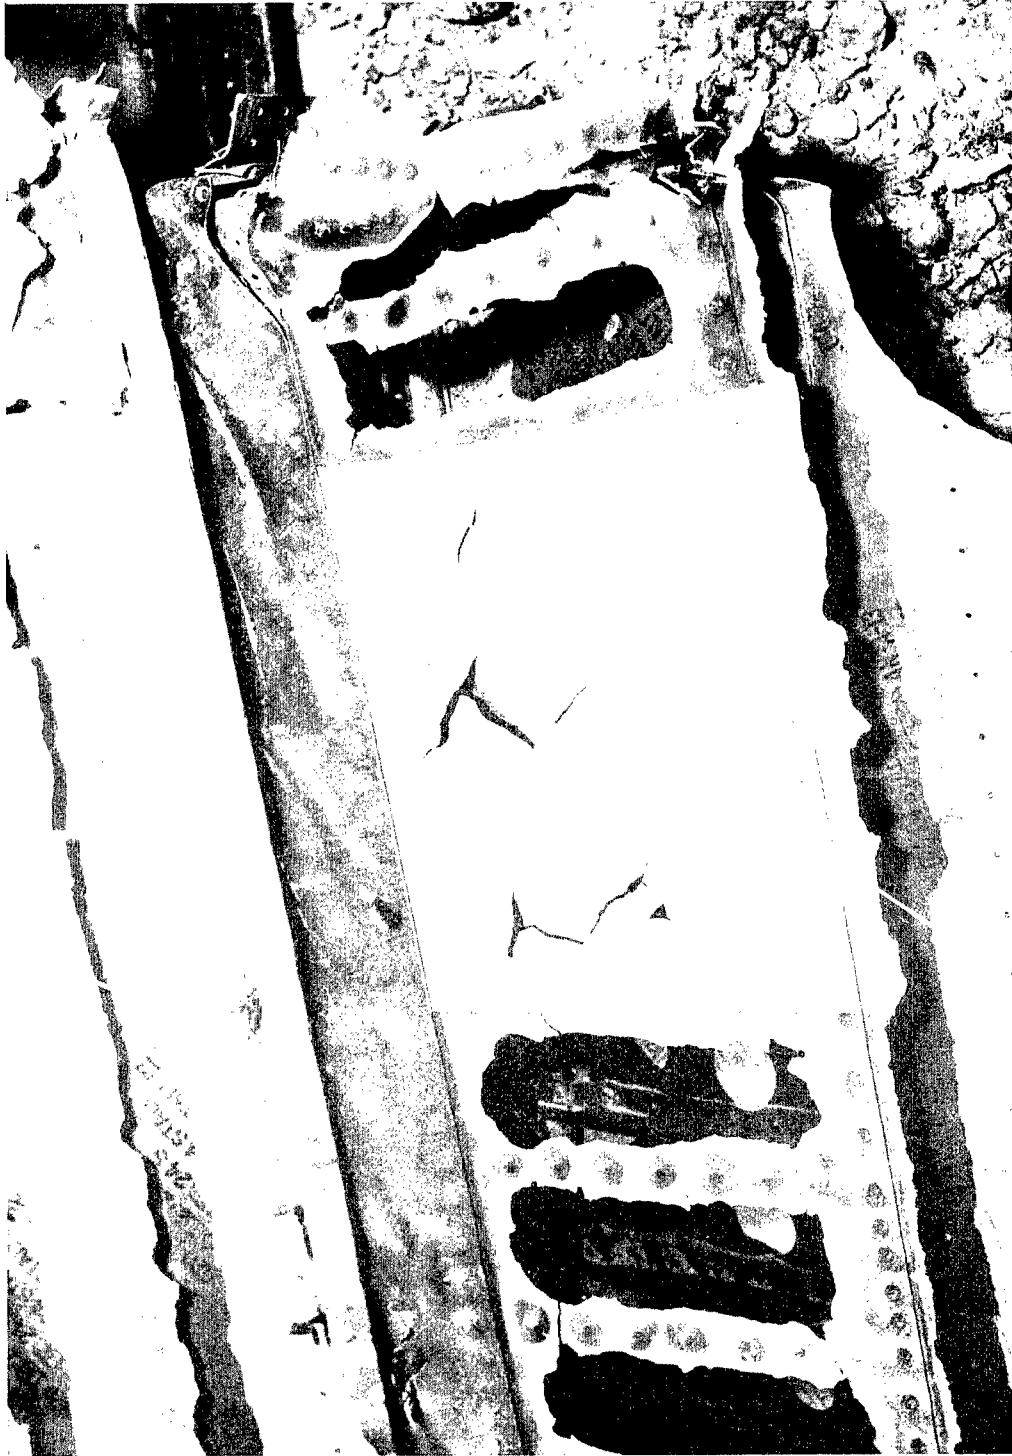
Fig. 2.12 AD-2, Port Aileron - Showing Relative Damage to Various Combinations of Surface Finish and Skin Thickness - Shot 7

Surface Finish	Effects	Figure No.
	<u>0.016 Skin Thickness</u>	
Standard Blue	Panels missing except for small circular pieces around each rivet	2.10; 2.11
Standard White	Panels missing except for edges	2.12; 2.19
Aluminized Lacquer	Panels missing except for edges	2.13; 2.14
Heat Resistant White	Panels remained intact	2.15
Bare Aluminum	Pieces missing; panel broken along center line	2.15
	<u>0.025 Skin Thickness</u>	
Standard Blue	Panel missing except for edges	2.10; 2.13
Standard White	Pieces missing; panel broken along center line	2.12
Aluminized Lacquer	Panel broken along center line	2.13

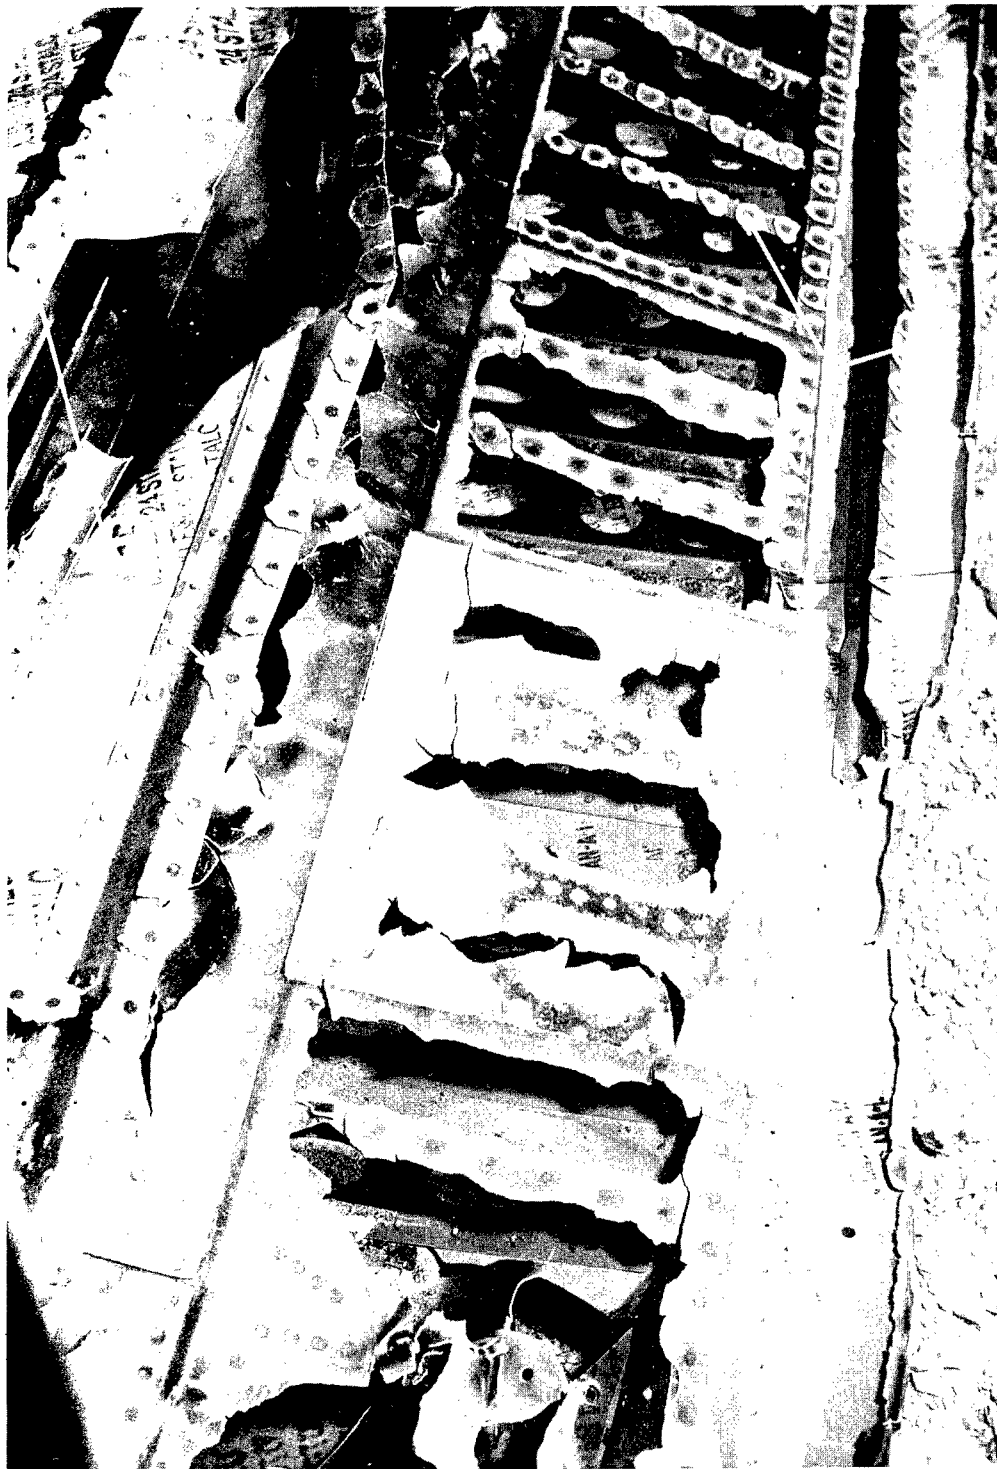
Fig. 2.13 AD-2, Starboard Aileron - Showing Thermal Damage to Aluminized Lacquered
0.025 Skin Compared with Standard Blue Painted 0.025 Skin - Shot 7

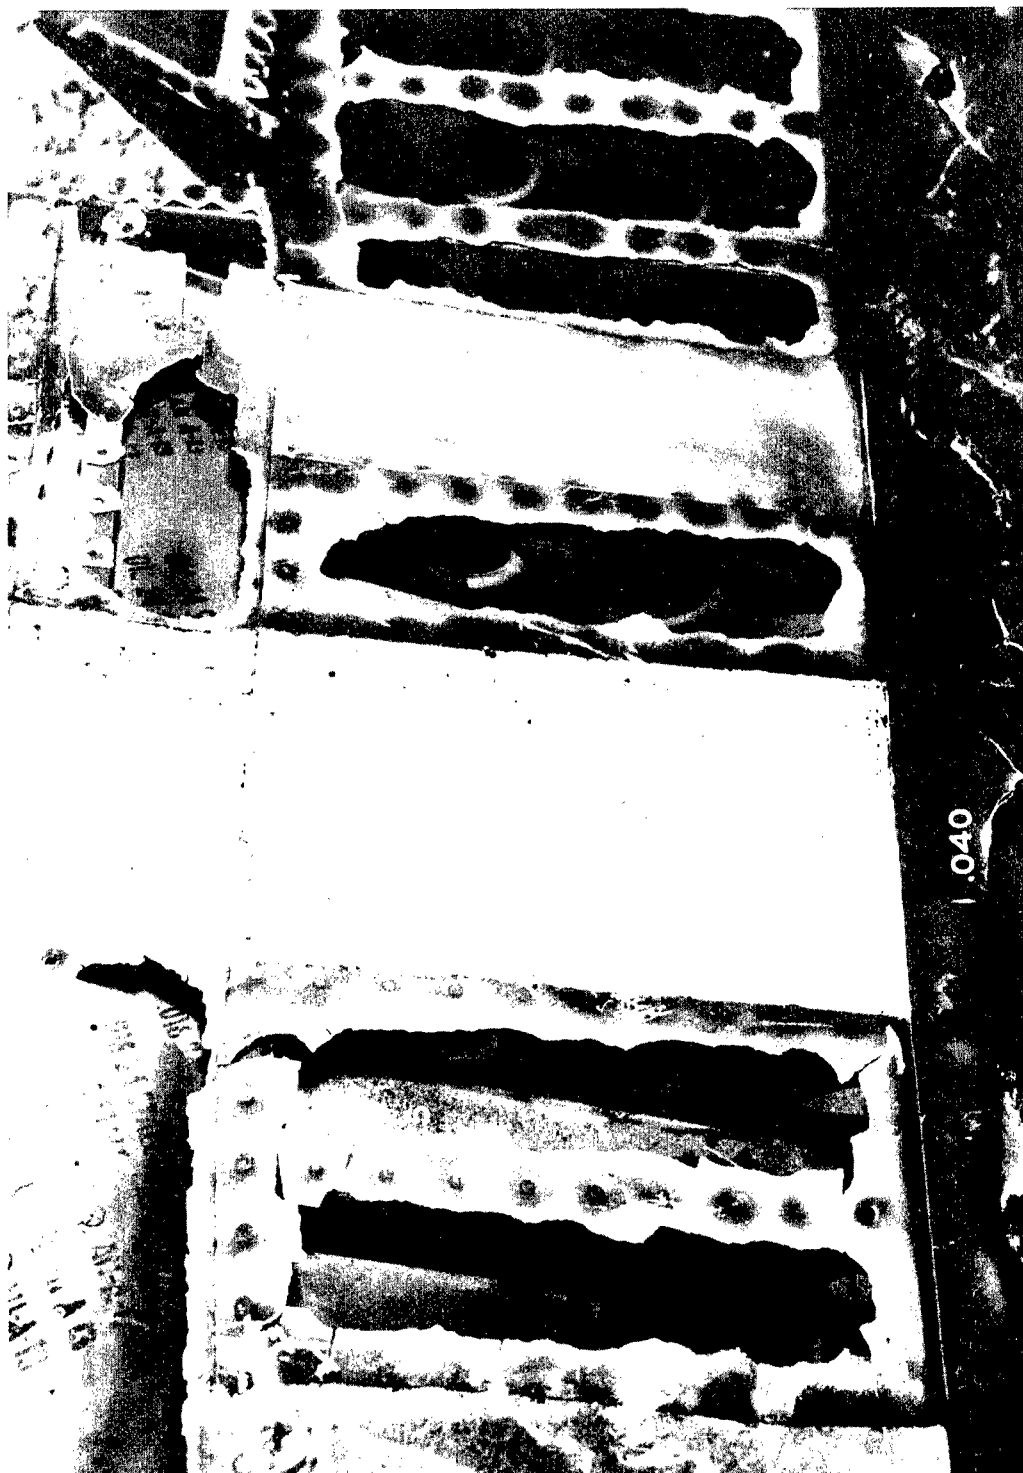
Fig. 2.14 AD-2, Port Aileron - Showing Thermal Damage to Aluminized Lacquered
0.025 Skin Compared with Standard Blue Painted 0.025 Skin - Shot 7

Surface Finish	Effects	Figure No.
Aluminized Lacquer	Pieces missing; panel broken along center line	2.14
Heat Resistant White	Panels remained intact	2.15
Bare Aluminum	Panels remained intact	2.15
Standard Blue	<u>0.032 Skin Thickness</u> Panel missing except for edges. NOTE: White lettering gave added protection.	2.16
Heat Resistant White	Panel remained intact	2.17
Standard Blue	<u>0.040 Skin Thickness</u> Pieces missing; panel broken along center line, except on narrow panels. NOTE: White lettering gave added protection.	2.18; 2.14; 2.16
Aluminized Lacquer	Panel remained intact	2.18
Standard Blue	<u>0.051 Skin Thickness (AL-3-SO)</u> Skin apparently unaffected; paint scorched	2.16

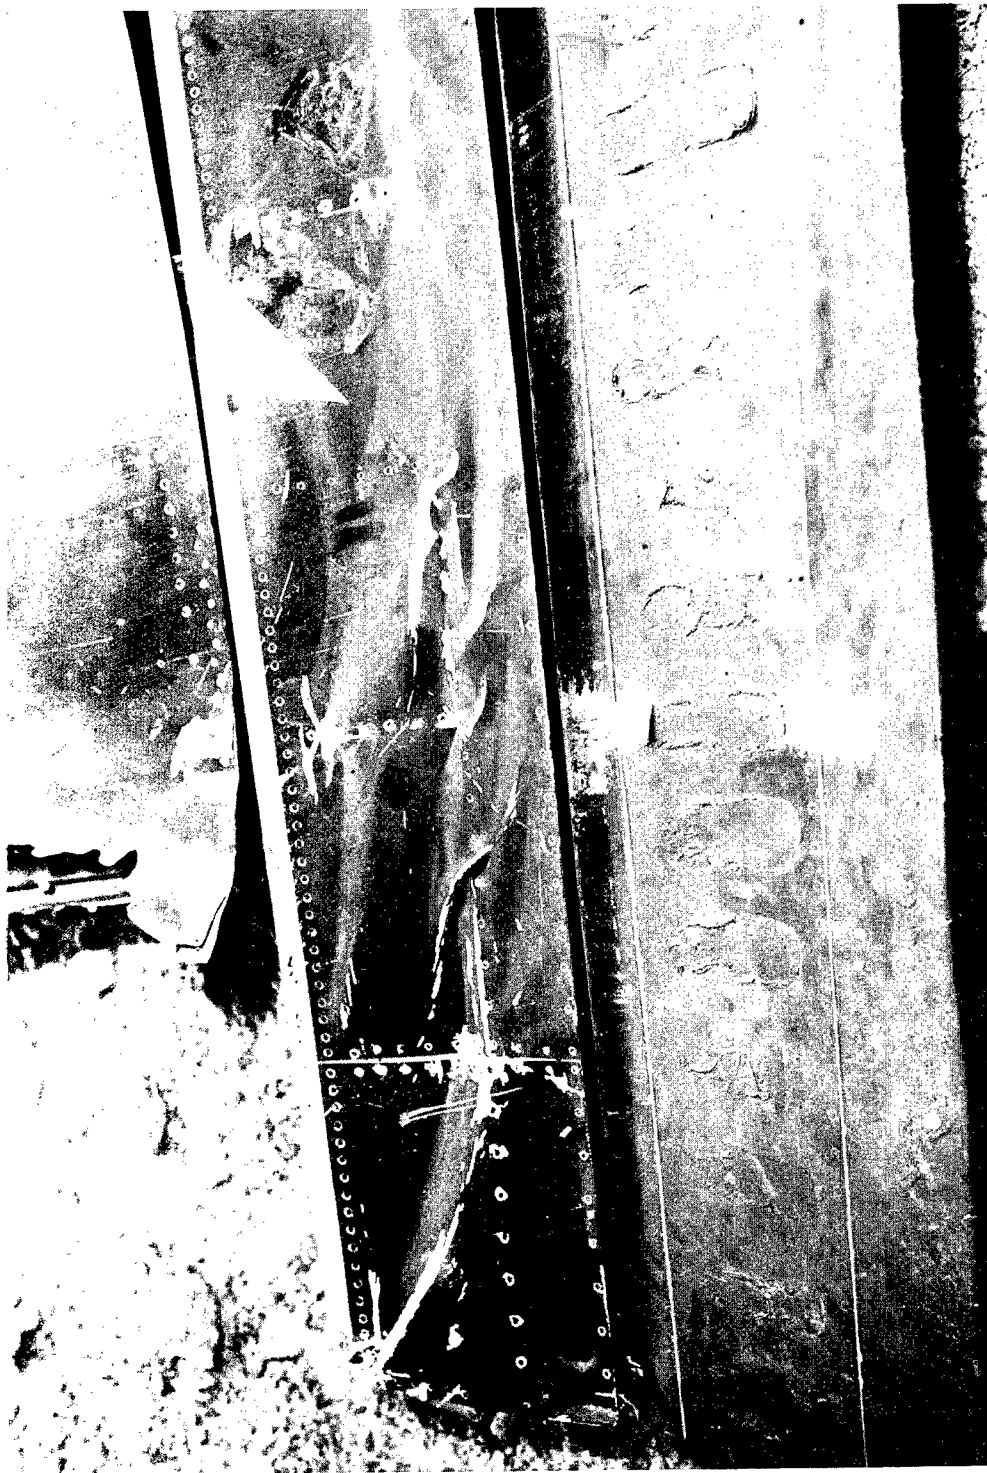
Fig. 2.19 AD-2, Tip of Elevator and Horizontal Stabilizer Showing
Fabric-Lightening Hole Covers and Elevator Tip Intact - Shot 7

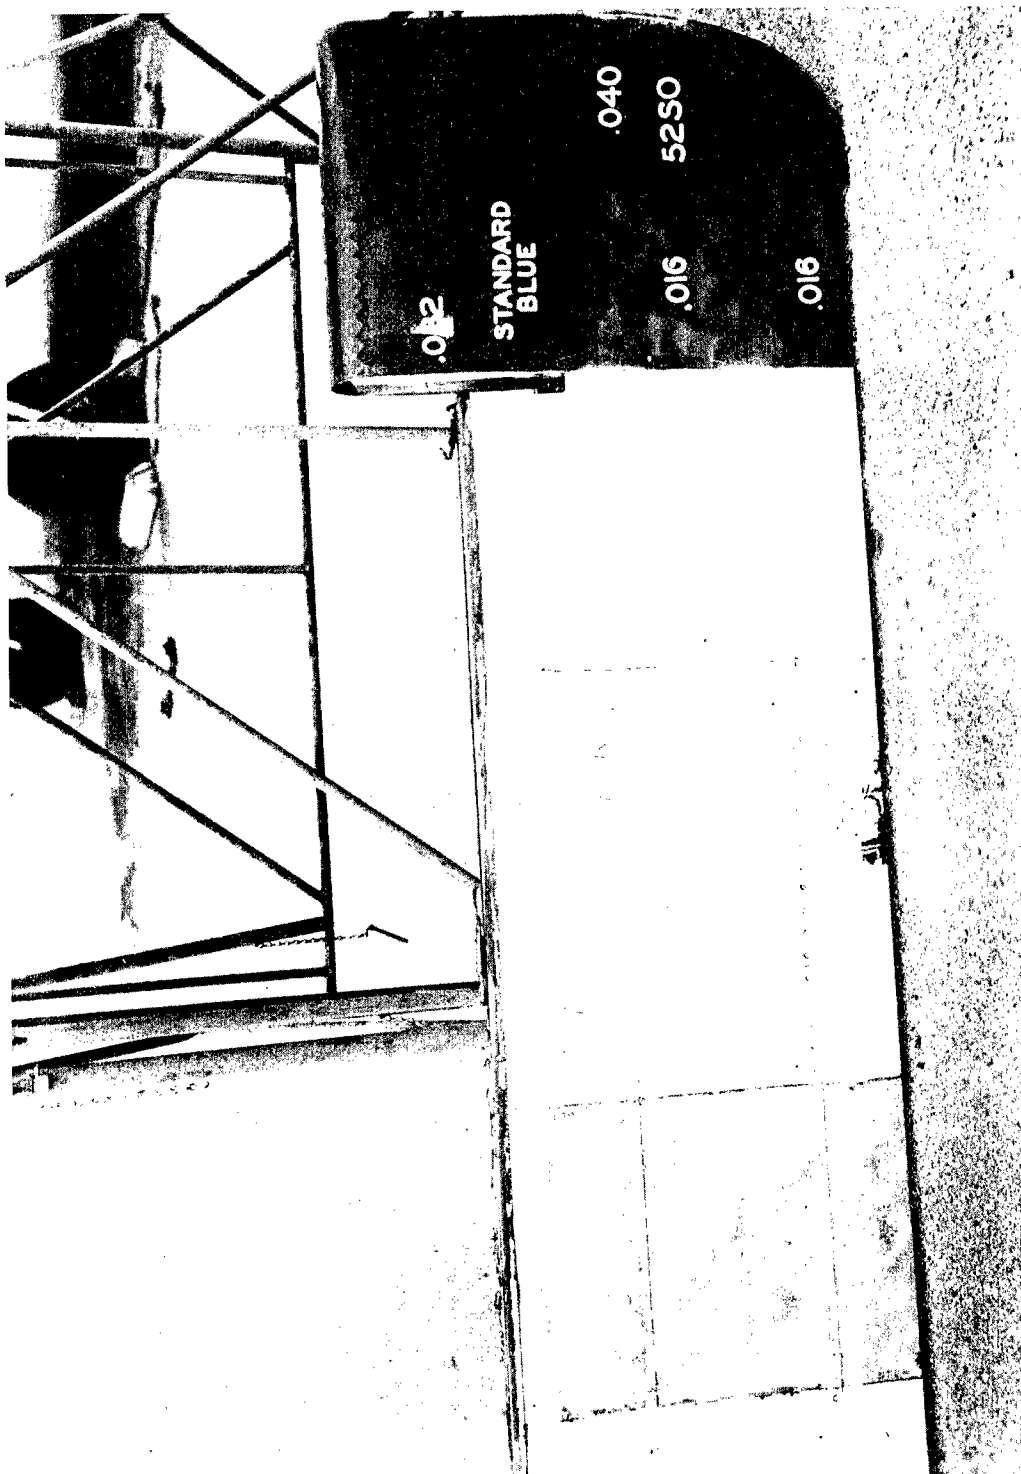
Fig. 2.22 XBT2D-1, Port Aileron Showing Scorched Standard White Paint on 0.016, 0.025 and 0.040 Skin - Shot 8

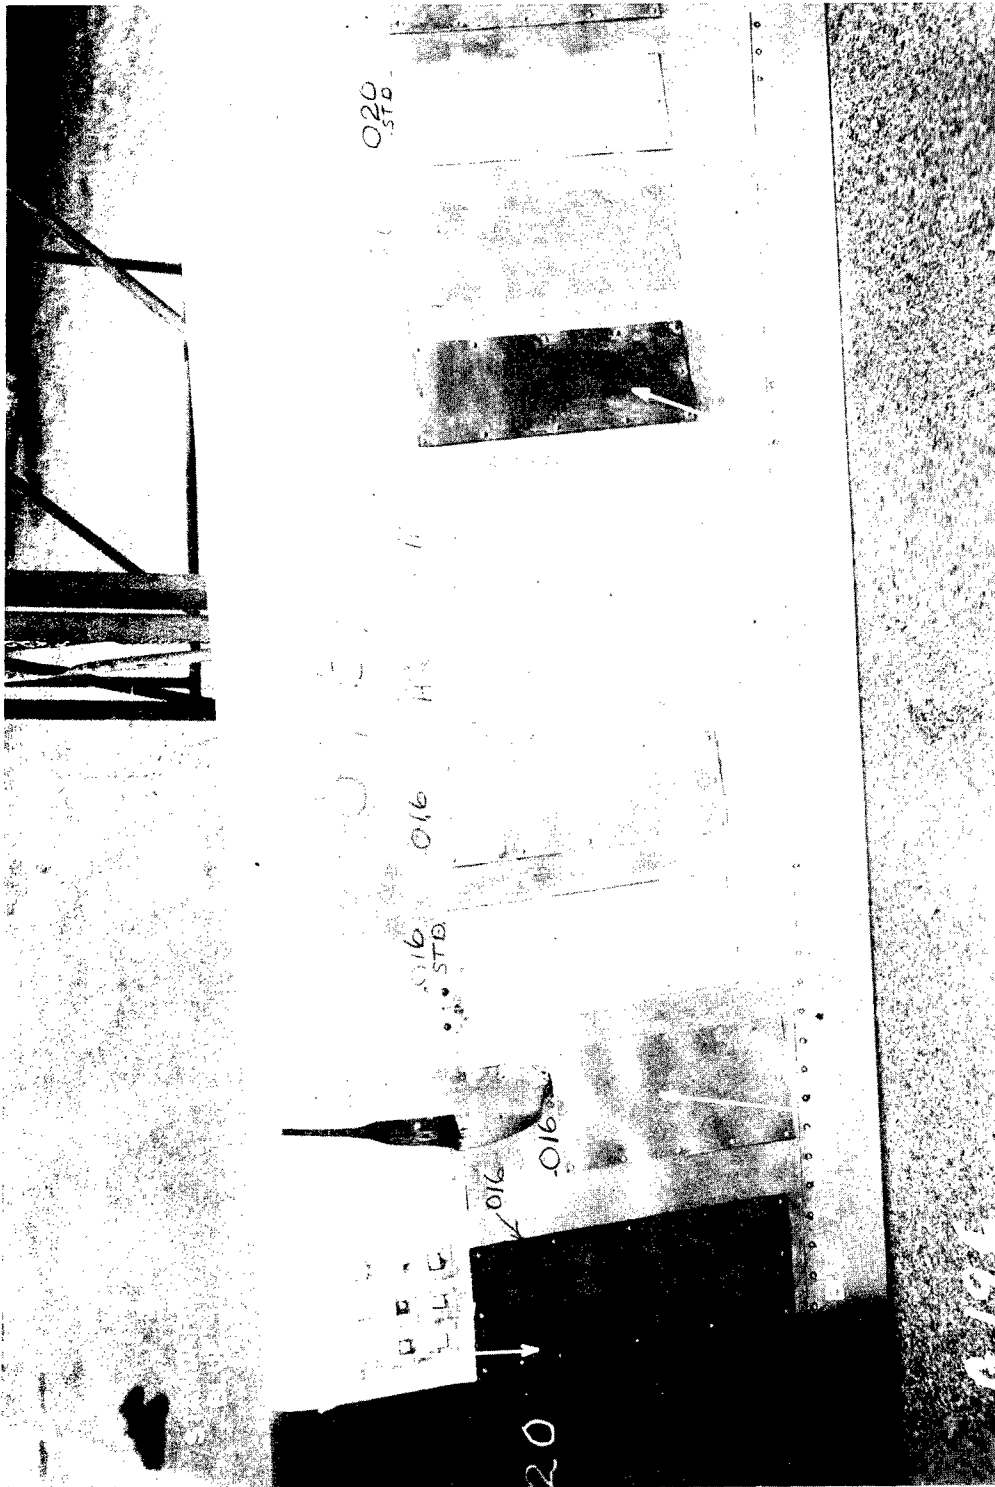
Fig. 2.23 XBT2D-1, Port Elevator Showing Scorched Painted Surfaces. Note skin ripples on 0.016 standard blue painted and aluminized lacquered surfaces. - Shot 8

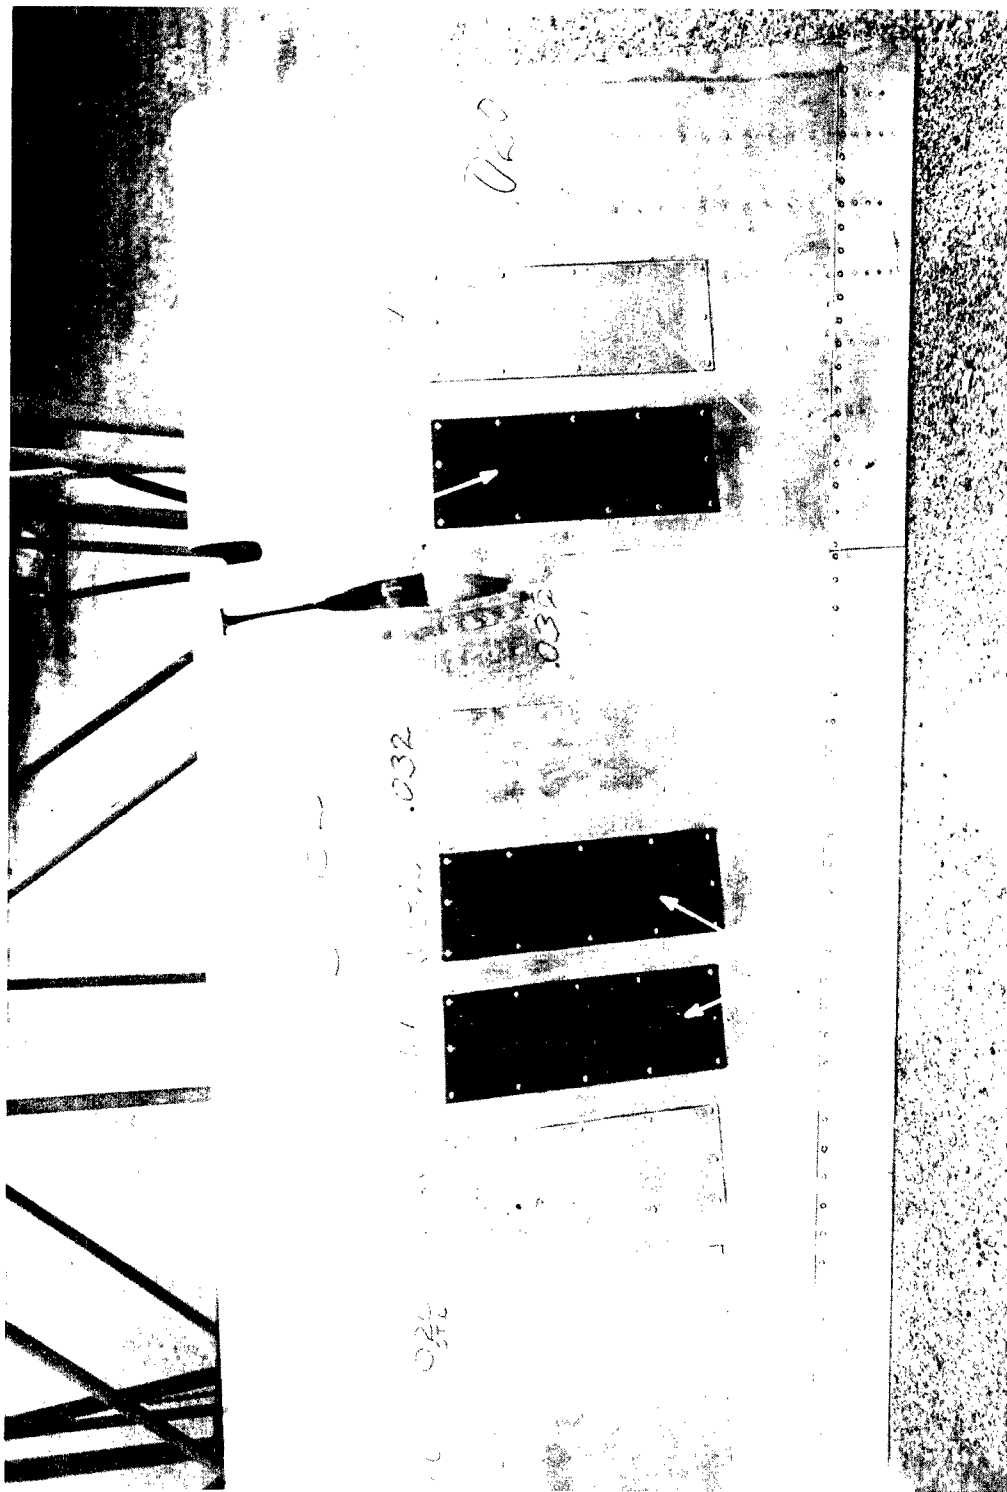
Fig. 2.24 XBT2D-1, Starboard Wing Flap with Thermal Test
Panels Installed, Outboard Portion - Shot 8

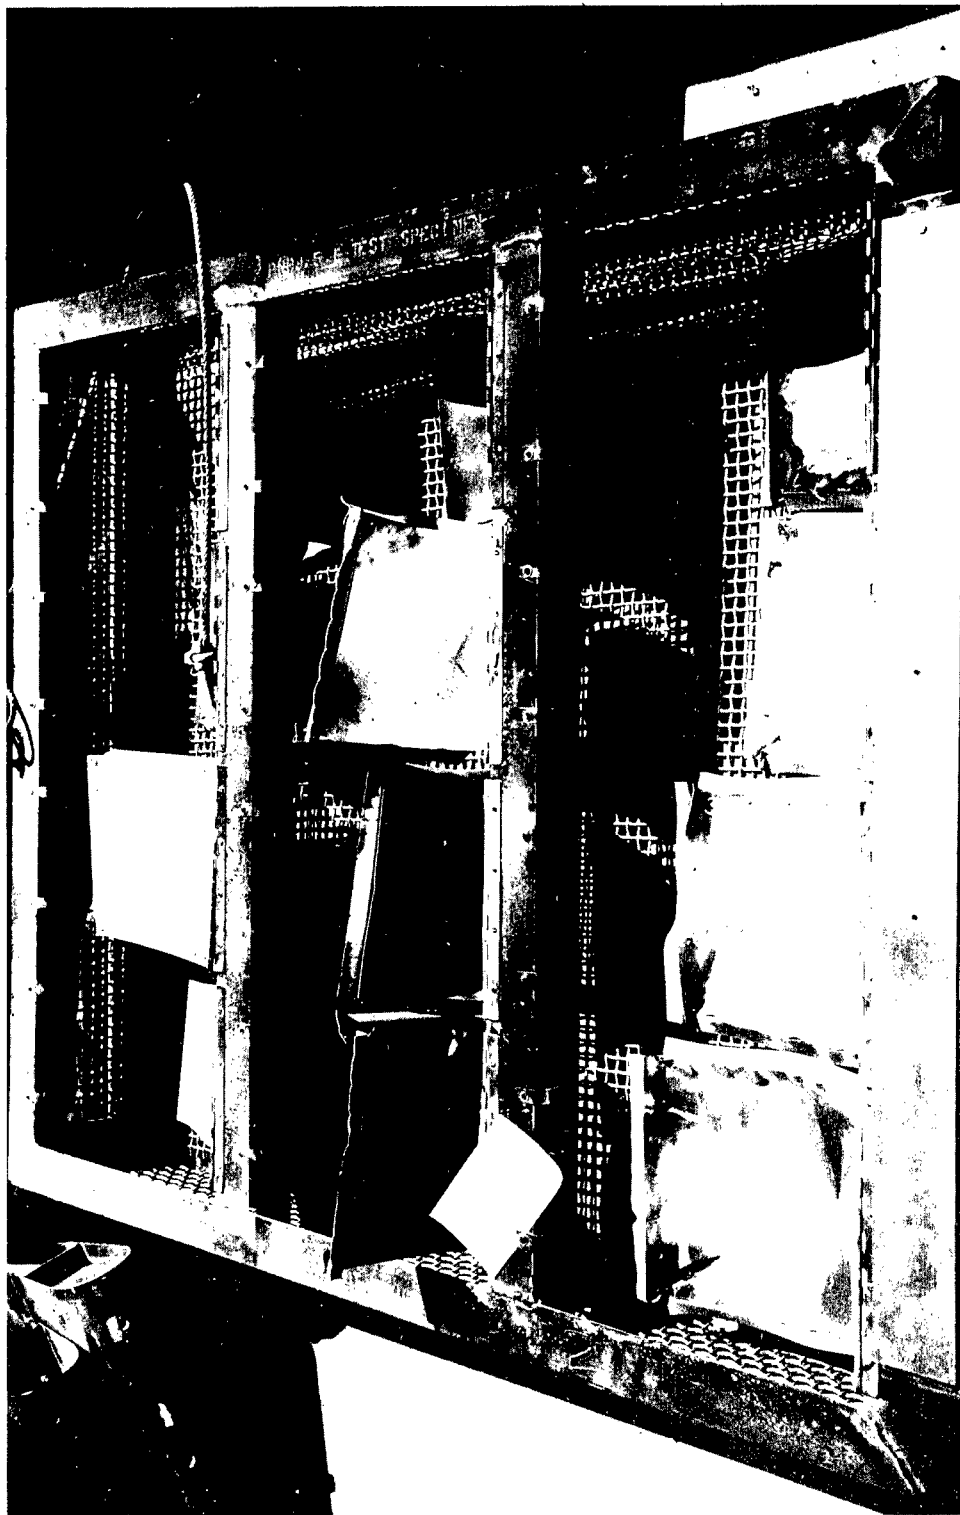
Fig. B.13 Frame Number 2 after Exposure - Slant
Range 5330 Ft, Thermal Energy 30 cal/cm²
